**Enhanced Preliminary
Assessment Report:**

**Hull Army Housing Units
Hull, Massachusetts**

September 1989

Environmental Research Division
Argonne National Laboratory
Argonne, Illinois 60439

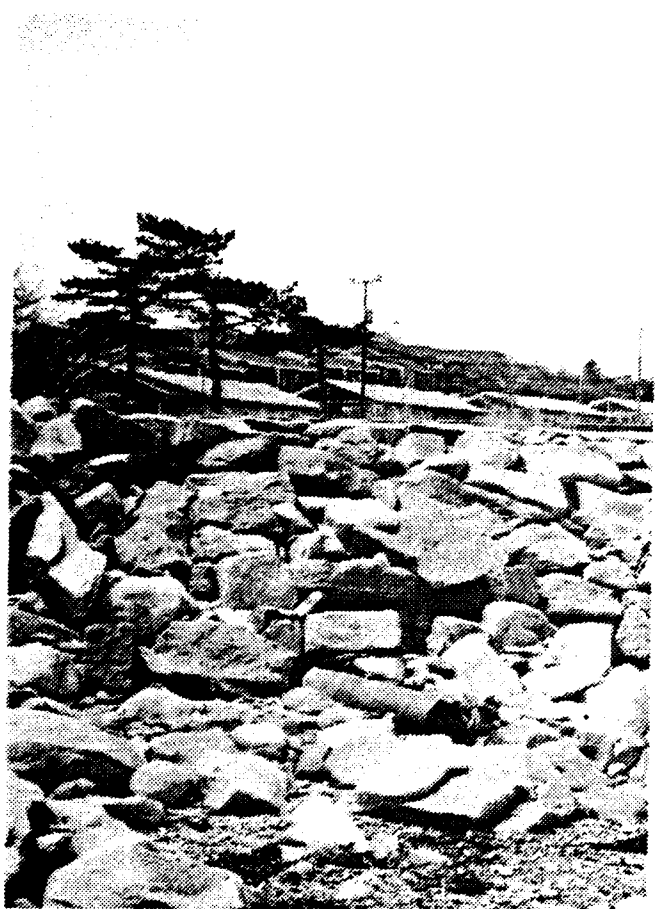
Upper left-hand photo:
Storm drainage overflow to Massachusetts Bay.

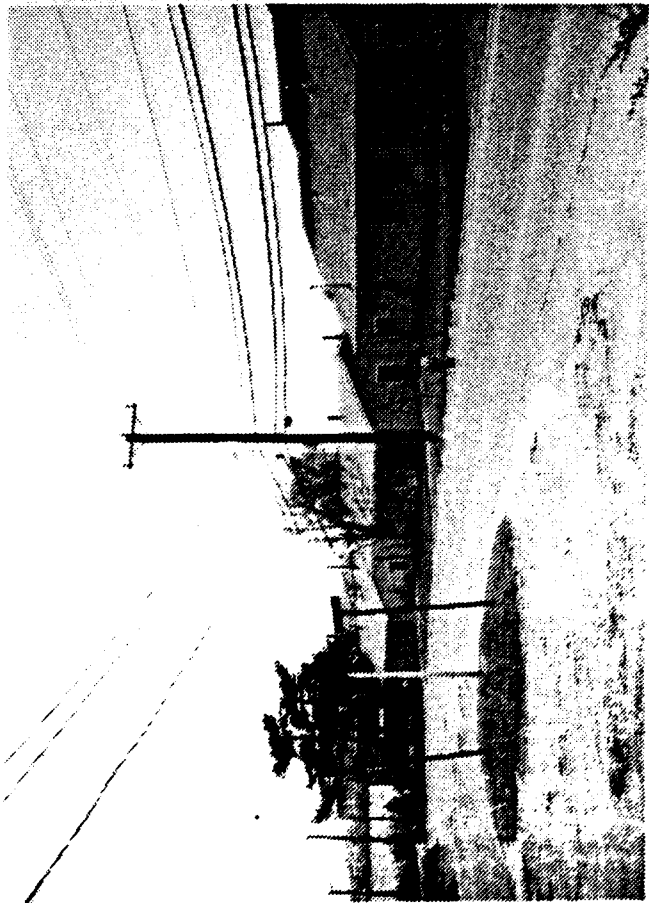
Front view of new siding and window casements.
